Test Report No.: SZXEC25000628305 Date: Mar 13, 2025 Page 1 of 4

Sample Name: Silica gel
Model No.: PAS-6750

Halogen

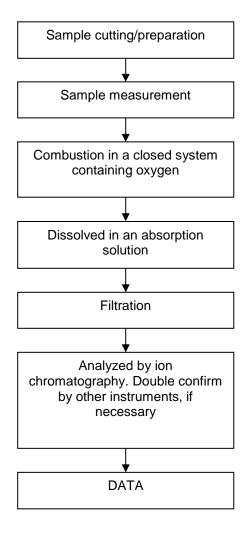
Halogen Testing Flow Chart

Test Method: With reference to EN 14582:2016, analysis was performed by IC.

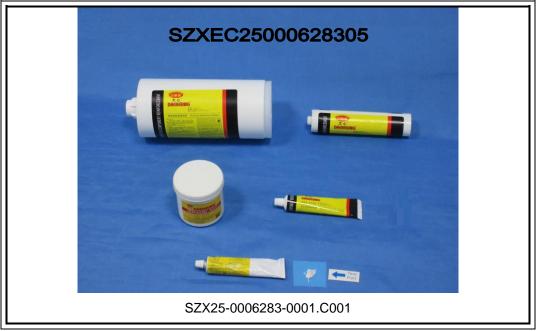
Sample Photo:

SN ID	Sample No.	SGS Sample ID	Description
SN1	A1	SZX25-0006283-0001.C001	White paste
